## CURRENT STATUS OF BITOU'S SOLID WASTE DISPOSAL FACILITIES

The Plettenberg Bay Ratepayers Association (PBRRA) is currently undertaking an investigation into the capacity of the Bitou's infrastructure to cope with the rapidly rising population. The investigation of the status and capacity of the solid waste collection and disposal facilities is being undertaken by Bill Alexander who has been representing the Associations interests in the portfolio for the last 2 years. During that time, he has interacted closely with the Manager for Integrated Waste, Douglas Baartman and has acted as the Chairman of the Bitou Waste Management Committee so he is well placed to make an assessment of the Municipality's waste management facilities.

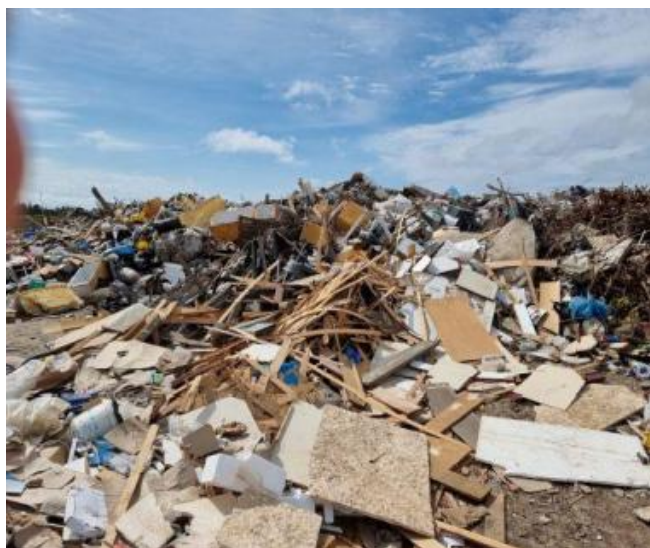
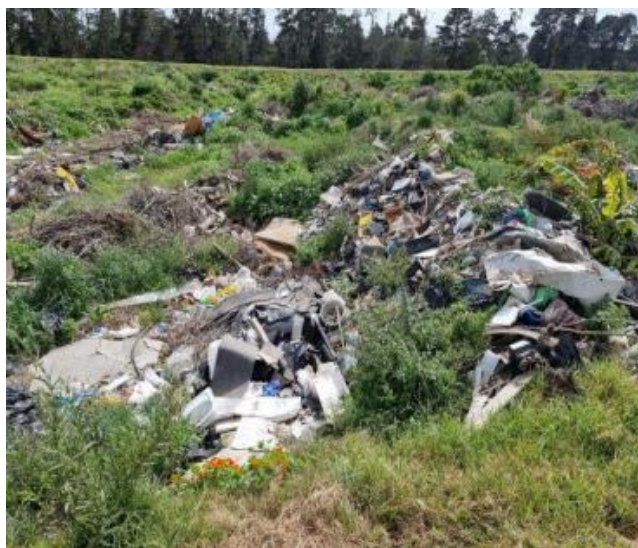
- a) The gate is poorly controlled. Items such as building rubble that are not meant to be disposed of on the site are allowed in and dumped indiscriminately, mainly on the site reserved for bulky waste site, but also on the site set aside for gardenwaste as shown in the photos below.

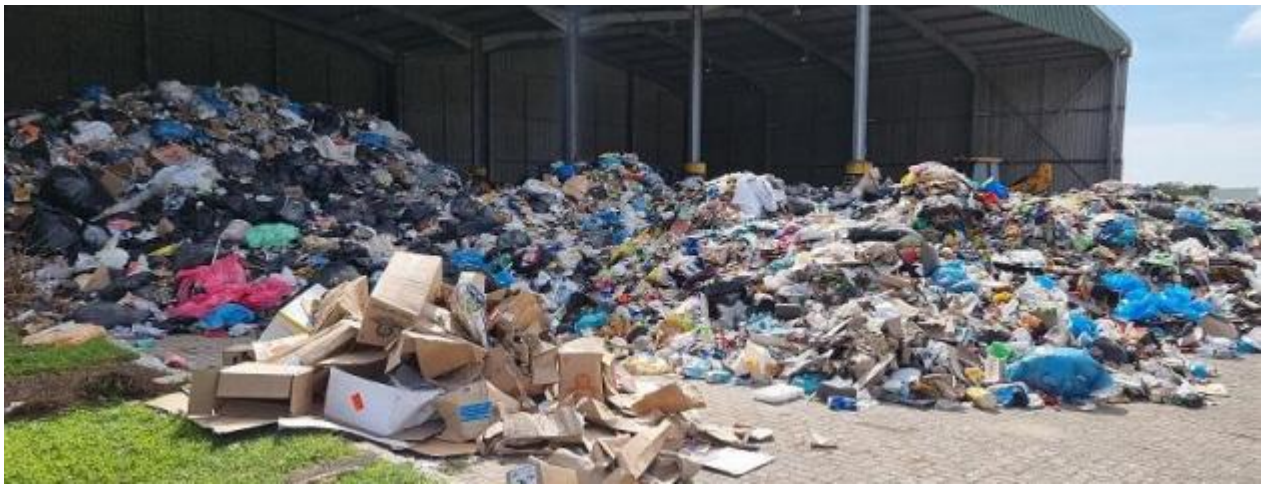
- a) Load shedding and breakdowns of the compacting ram or transporting trucks lead to large stockpiles building up on the slab as shown in the picture below

- b) On the day that the picture was taken the TLB (seen in the background) for loading the waste into the compactor had been out of commission for a week because the battery had failed and procuring a new one was mired in red tape.
- c) For the stockpile to be removed a TLB had to be rented daily at significant cost.
- d) It will be seen from the picture that the waste has a very high content of recyclable material which is unnecessarily having to be carted all the way to Mossel Bay at significant cost.
- e) There are two reasons why build ups of waste like this occur:
  - i. When the compacting ram goes down either due to load shedding or mechanical failure.
  - ii. When the hook lift trucks or trailers used to transport waste to Mossel Bay break down.

- a) The two TLBs should be allocated to other duties within the municipality and should be replaced by front end loaders that are more fit for purpose with large loading buckets. This will increase the efficiency of the waste handling on the site.
- b) The chipping machine should be replaced by a horizontal grinder that is more suited to breaking up all manner of garden waste. This will facilitate composting and disposal of the garden waste. The existing chipper can be used at the drop off stations to reduce the volume of waste that has to be transported to the Transfer Station.
- c) A standby generator should be provided so that the waste compactor can operate during load shedding

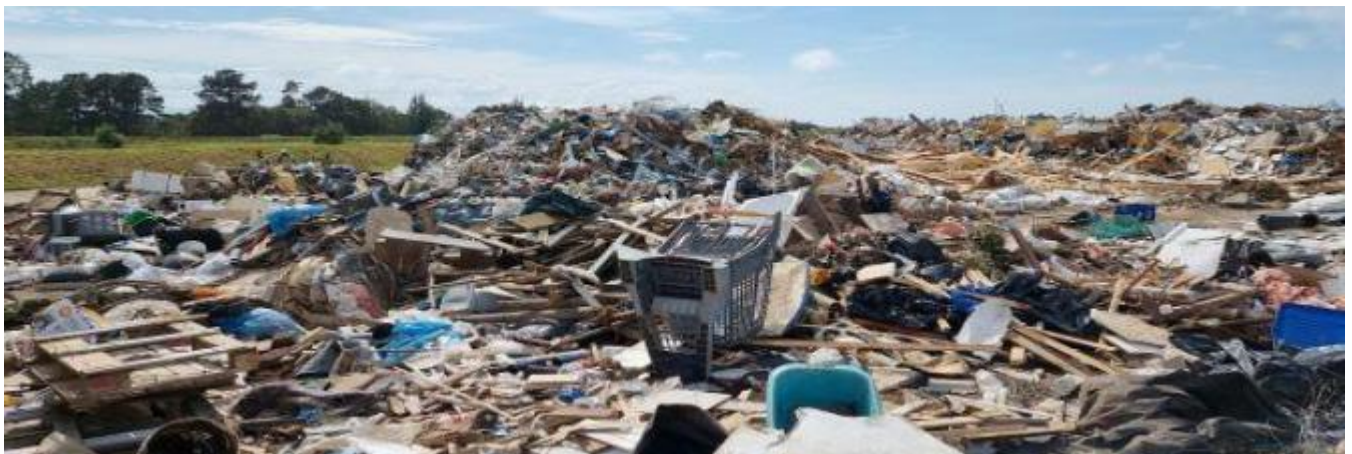
Currently the waste is brought to site by private citizens and contractors and is indiscriminately dumped at the site within the transfer station allocated to it, and large stockpiles are allowed to build up as shown in the photograph below.

- a) As will be seen from the photo the stockpile has been built up without any control and all types of material are totally mixed. It is estimated that there is approximately 1500 tons in the current stockpile.
- b) Much of the material does not qualify as bulky and is made up of:

- i. Domestic waste and should be compacted prior to being transported.
  - ii. Building rubble and should not be on the site at all.
  - iii. Garden waste that should be chipped and disposed of to gardeners etc.
  - iv. Recyclable material and should be recovered and sold rather than be sent to landfill.
- c) Most of the above problems could be solved by proper gate control and site supervision cope with the volume of waste delivered to the site.
  - d) It is estimated that it will cost approximately R4 million to load and cart the waste to the landfill at Mossel Bay. The waste cannot be compacted and so the volume per ton transported is very high which makes it expensive.
  - e) The transport of the waste is put out to tender and there is currently a delay in the procurement department in awarding the contract for the removal of the current stockpile.

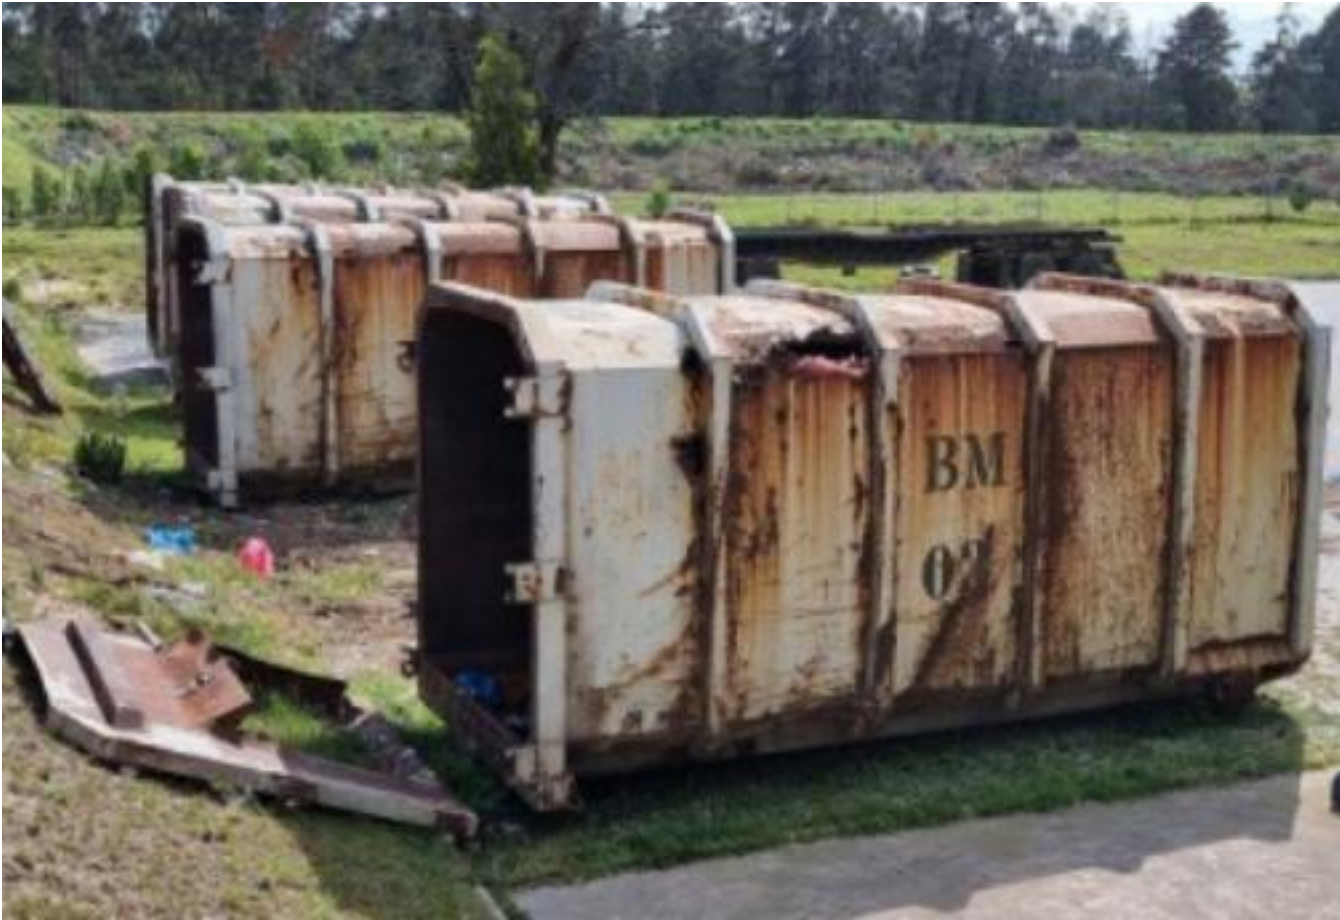
- a) There are currently 8 containers of which only 6 are operational.
- b) The containers are generally in poor condition as will be seen in the photographs below.

- c) Six containers are required every day so there are no backups available.
- d) If they were to fail they would create a serious bottleneck in the system

- a) The quantity of waste to be transport should be reduced as much as possible by proper controls and recycling.
- b) The compacting containers are reaching the end of their useful lives and should be progressively replaced. Without them the transport system cannot function.

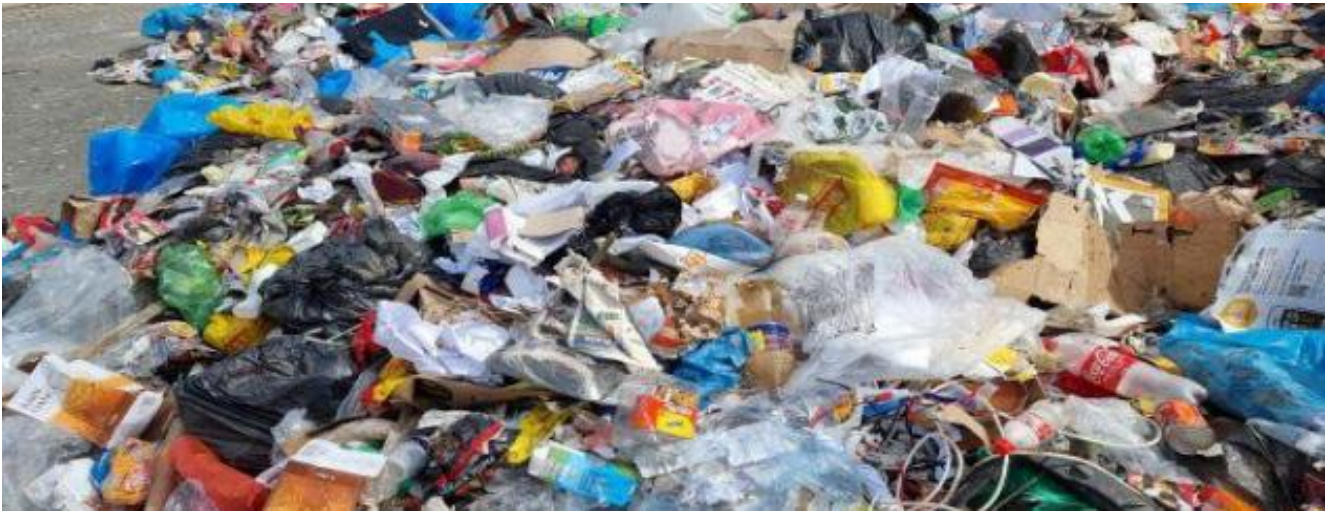
- f) The management of the bulky waste also provides a clear opportunity for improving

the recycling effort and consideration should be given to including this activity within the scope of the new recycling service provider contract.
